Manhole Inspection Summary

Manhole # S11S__012MH

Location Address: **810 S. Caton Ave**

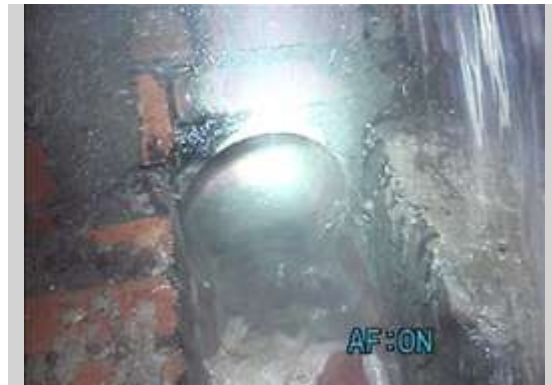
Drop In @ 4 O'Clock

Drop: **Inside** Rod and Bar
Angled: **Yes** Reading: **6.30** (ft.)
Inv Depth: **7.30** (ft.)

Drop Condition: **Open**

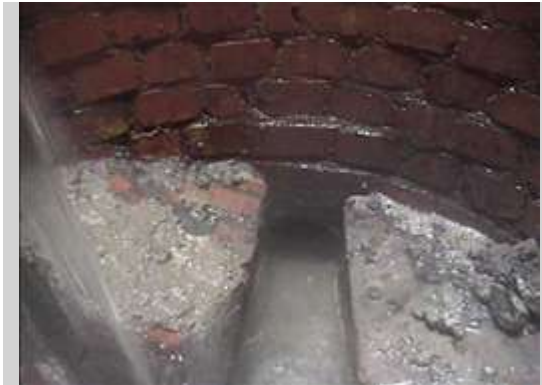
Drop In @ 6 OClock

Evidence of infiltration in Barrel

Infiltration: **Evidence** Pipe Seal Cond: **Unknown**
